Case 276 : Narrative

Case Vehicle (A): 1999 Nissan
Type: Altima, 4-door sedan
Driver: 37-year-old female
CDC: 12-FCEN-3

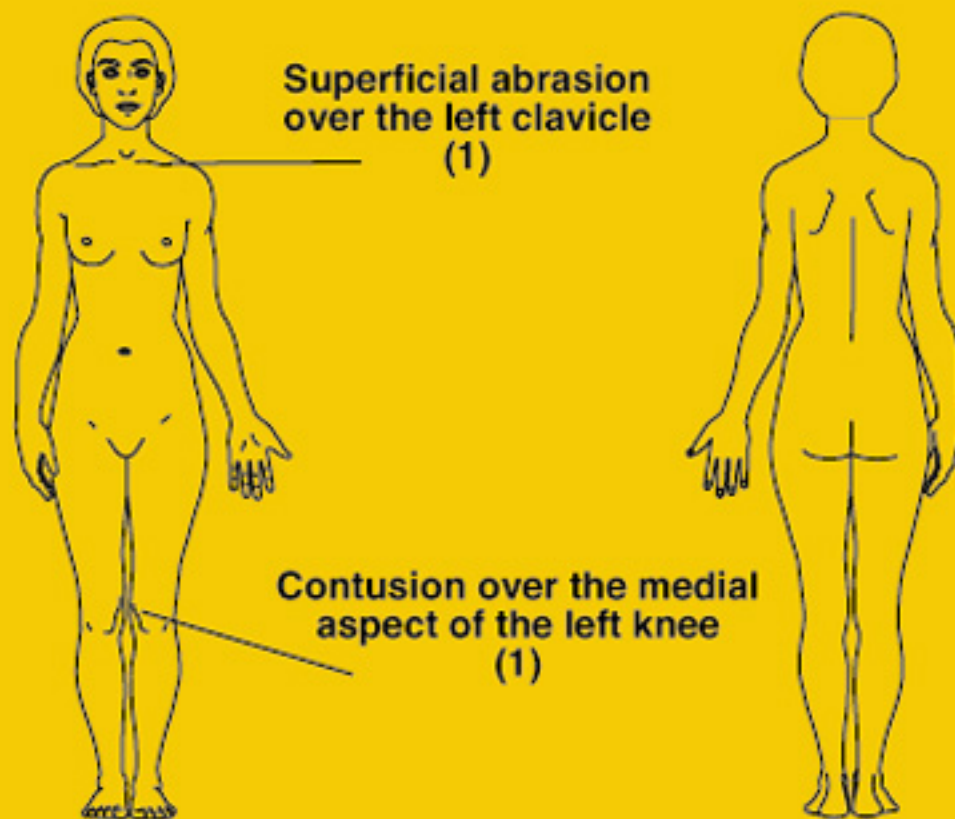
The driver sustained a superficial abrasion over the left clavicle from loading by the shoulder belt. [48](#) In addition, she sustained a contusion over the medial aspect of the left knee from contact with the left portion of the knee bolster, as indicated by a scuff mark on the panel. [49](#) Damage to the right portion of the knee bolster indicates driver contact, but no corresponding injuries were reported.

Occupant: Driver	Age: 37 years	Gender: Female		
Restraints: 3-point belt worn; airbag deployed	Stature: Unknown	Mass: Unknown		
Injury Description	A.I.S.	Injury Source		
		Definite	Probable	Possible
—	—			
Superficial abrasion over the left clavicle	1	Shoulder belt	—	—
Contusion over the medial aspect of the left knee	1	Knee bolster	—	—
Maximum A.I.S. Level	1	—	—	—
Injury Severity Score	1	—	—	—

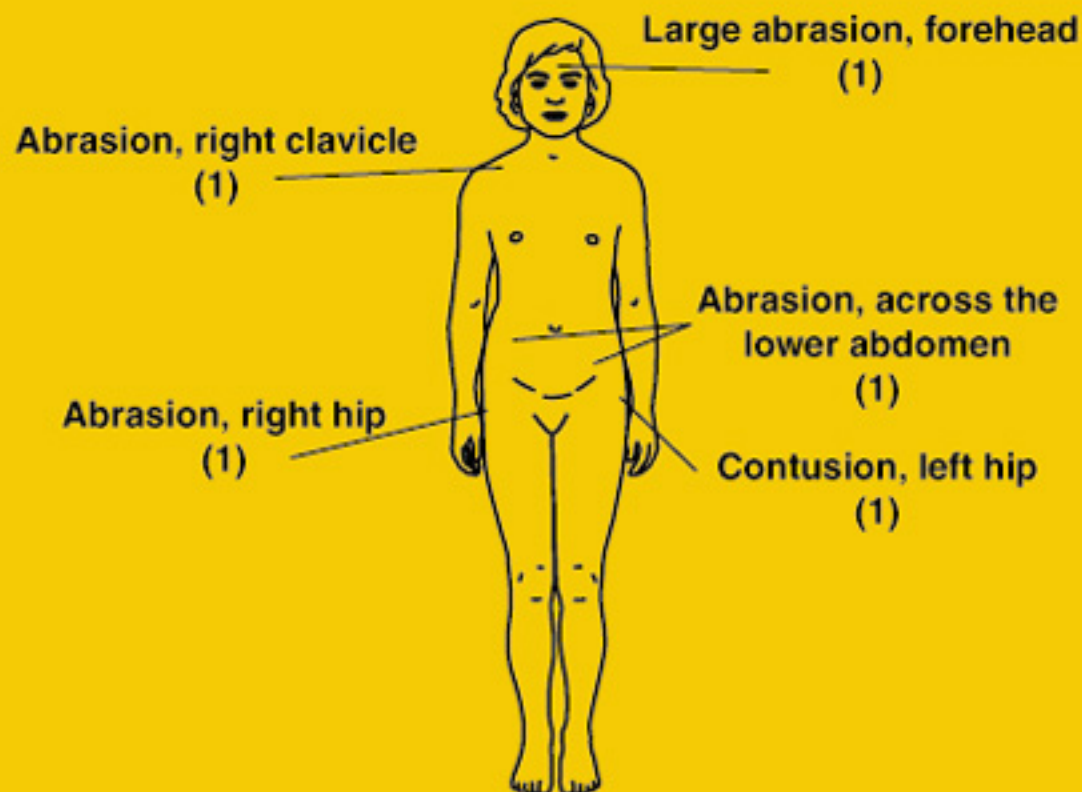
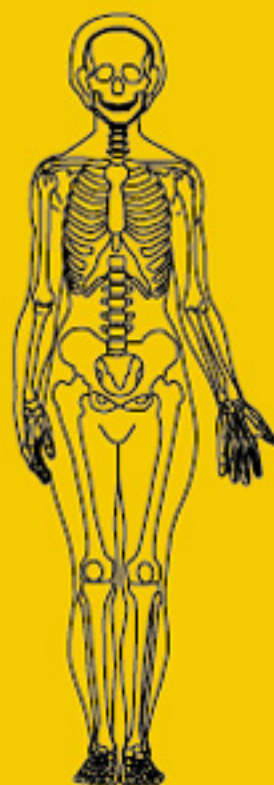
During the frontal impact with the tree, the right-front child passenger moved forward relative to the vehicle interior into the belt restraint and the airbag. She sustained a large abrasion to the forehead from contact by the deploying airbag. She sustained an abrasion to the right clavicle from loading by the shoulder belt. In addition, she sustained an abrasion across the lower abdomen, an abrasion to the right hip, and a contusion to the left hip, from loading by the lap belt. [56](#) Damage to the glove box suggests passenger contact, but no corresponding injuries were reported.

Occupant: Right front	Age: 8 years	Gender: Female		
Restraints: 3-point belt worn; airbag deployed	Stature: Unknown	Mass: Unknown		
Injury Description	A.I.S.	Injury Source		
—	—	Definite	Probable	Possible
Large abrasion, forehead	1	Airbag	—	—
Abrasion, right clavicle	1	Shoulder belt	—	—
Abrasion, across the lower abdomen	1	Lap belt	—	—
Abrasion, right hip	1	Lap belt	—	—
Contusion, left hip	1	Lap belt	—	—
Maximum A.I.S. Level	1	—	—	—
Injury Severity Score	1	—	—	—

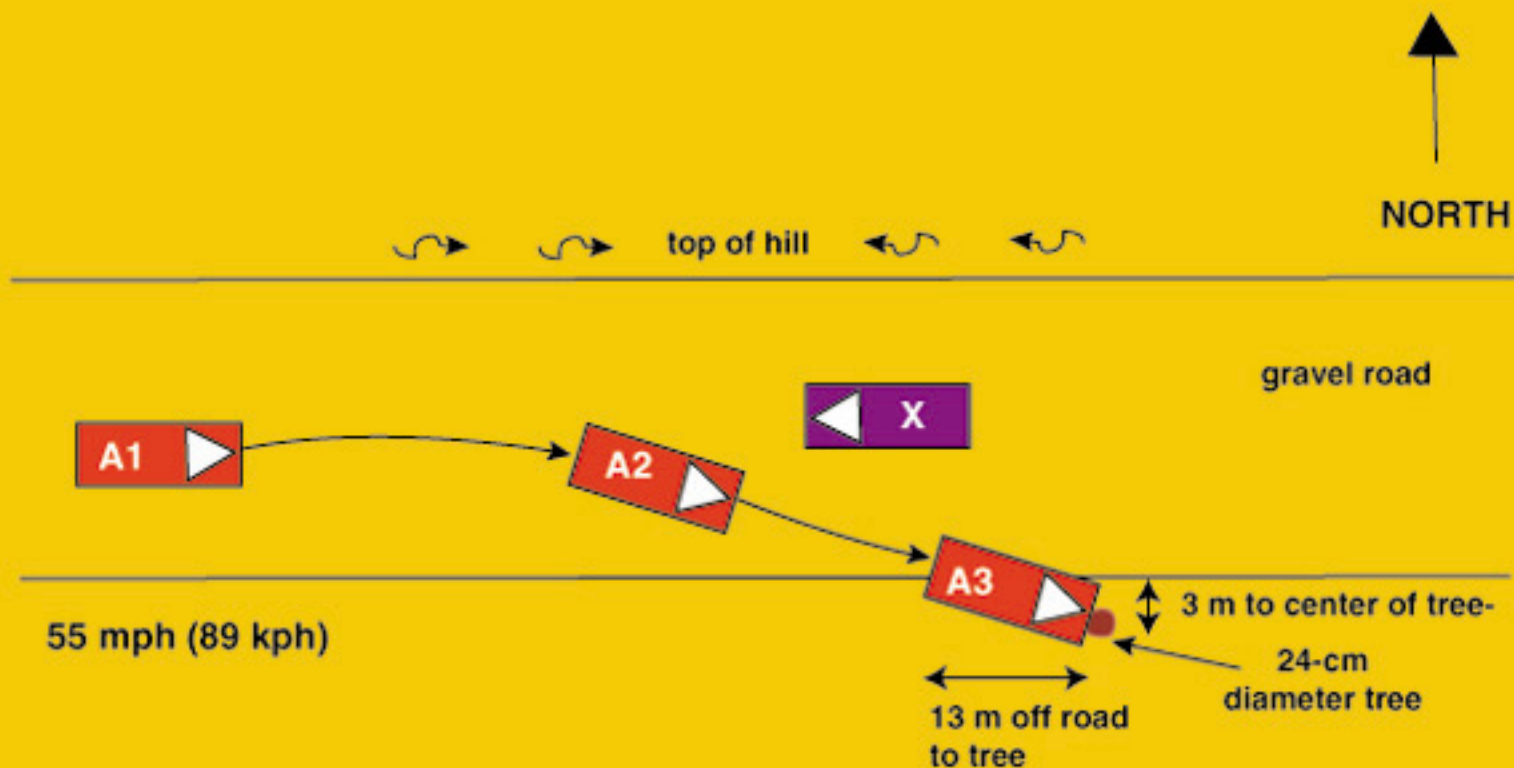
[1](#) [2](#) On a clear day, case vehicle (A) was traveling east at an unknown speed on a two lane, two-way gravel road in a rural area. It was daylight, the road was dry, and the posted speed limit was 55 mph (89 kph). The driver reportedly was traveling near the center of the road, because the road was recently graded. Vehicle (X) was traveling west, near the center of the same road at an unknown speed. As case vehicle (A) crested the top of a slight hill in the road, the driver observed the oncoming vehicle (X). The driver steered quickly to the right to avoid vehicle (X). [3](#) [4](#) [5](#) Case vehicle (A) exited the south edge of the road into a grassy area, where it struck a 24-cm diameter tree, located 3 meters south of the road edge, with its front. The vehicle was towed from the scene due to damage. The police reported "B" injuries for both the belt-restrained driver and the right-front child occupant, and they were transported to the hospital by ambulance.
